CONNECTICUT RIVER BASIN  
BLOOMFIELD, CONNECTICUT

# **COLD SPRING RESERVOIR DAM CT 00495**

## **PHASE I INSPECTION REPORT NATIONAL DAM INSPECTION PROGRAM**

MAY 1981

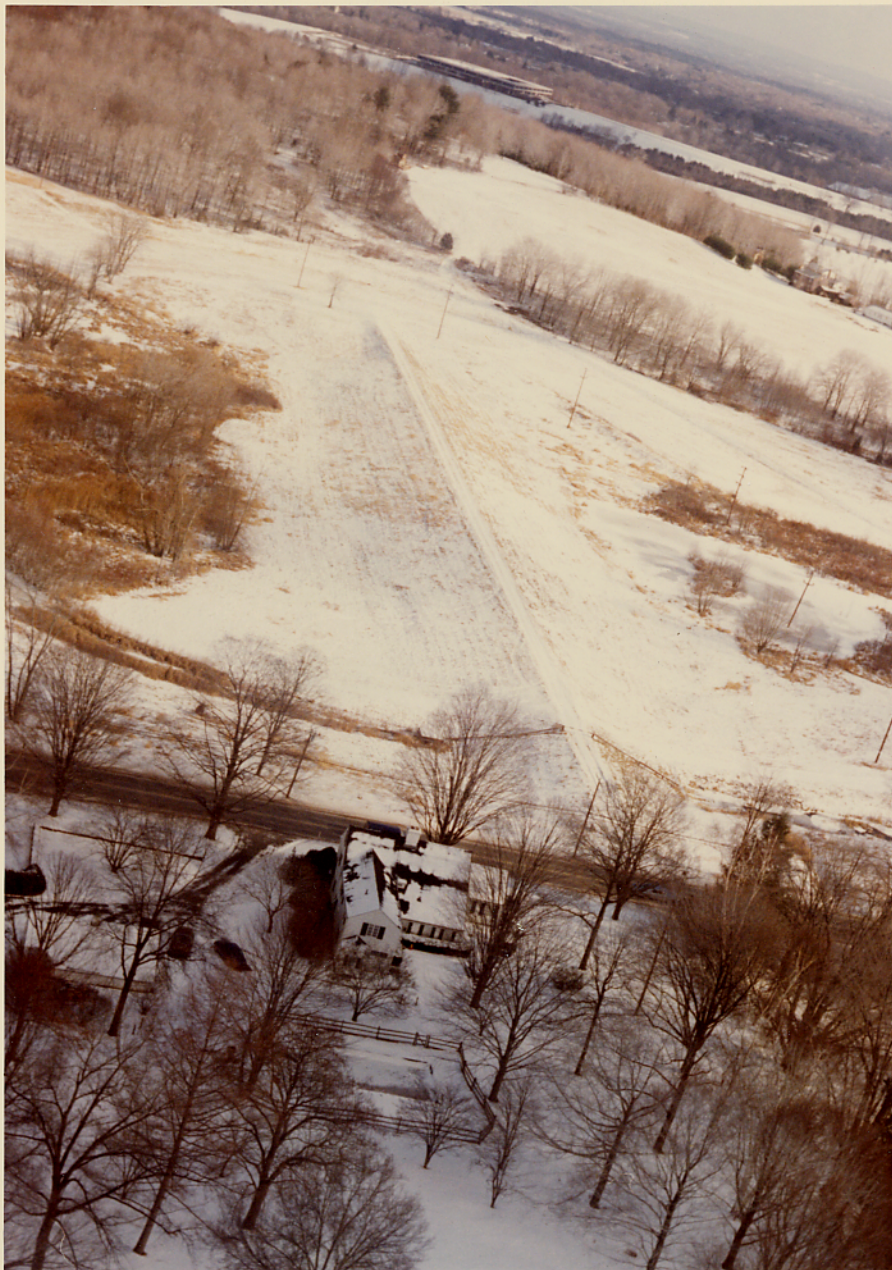
OVERVIEW PHOTO TAKEN DECEMBER 20, 1980.

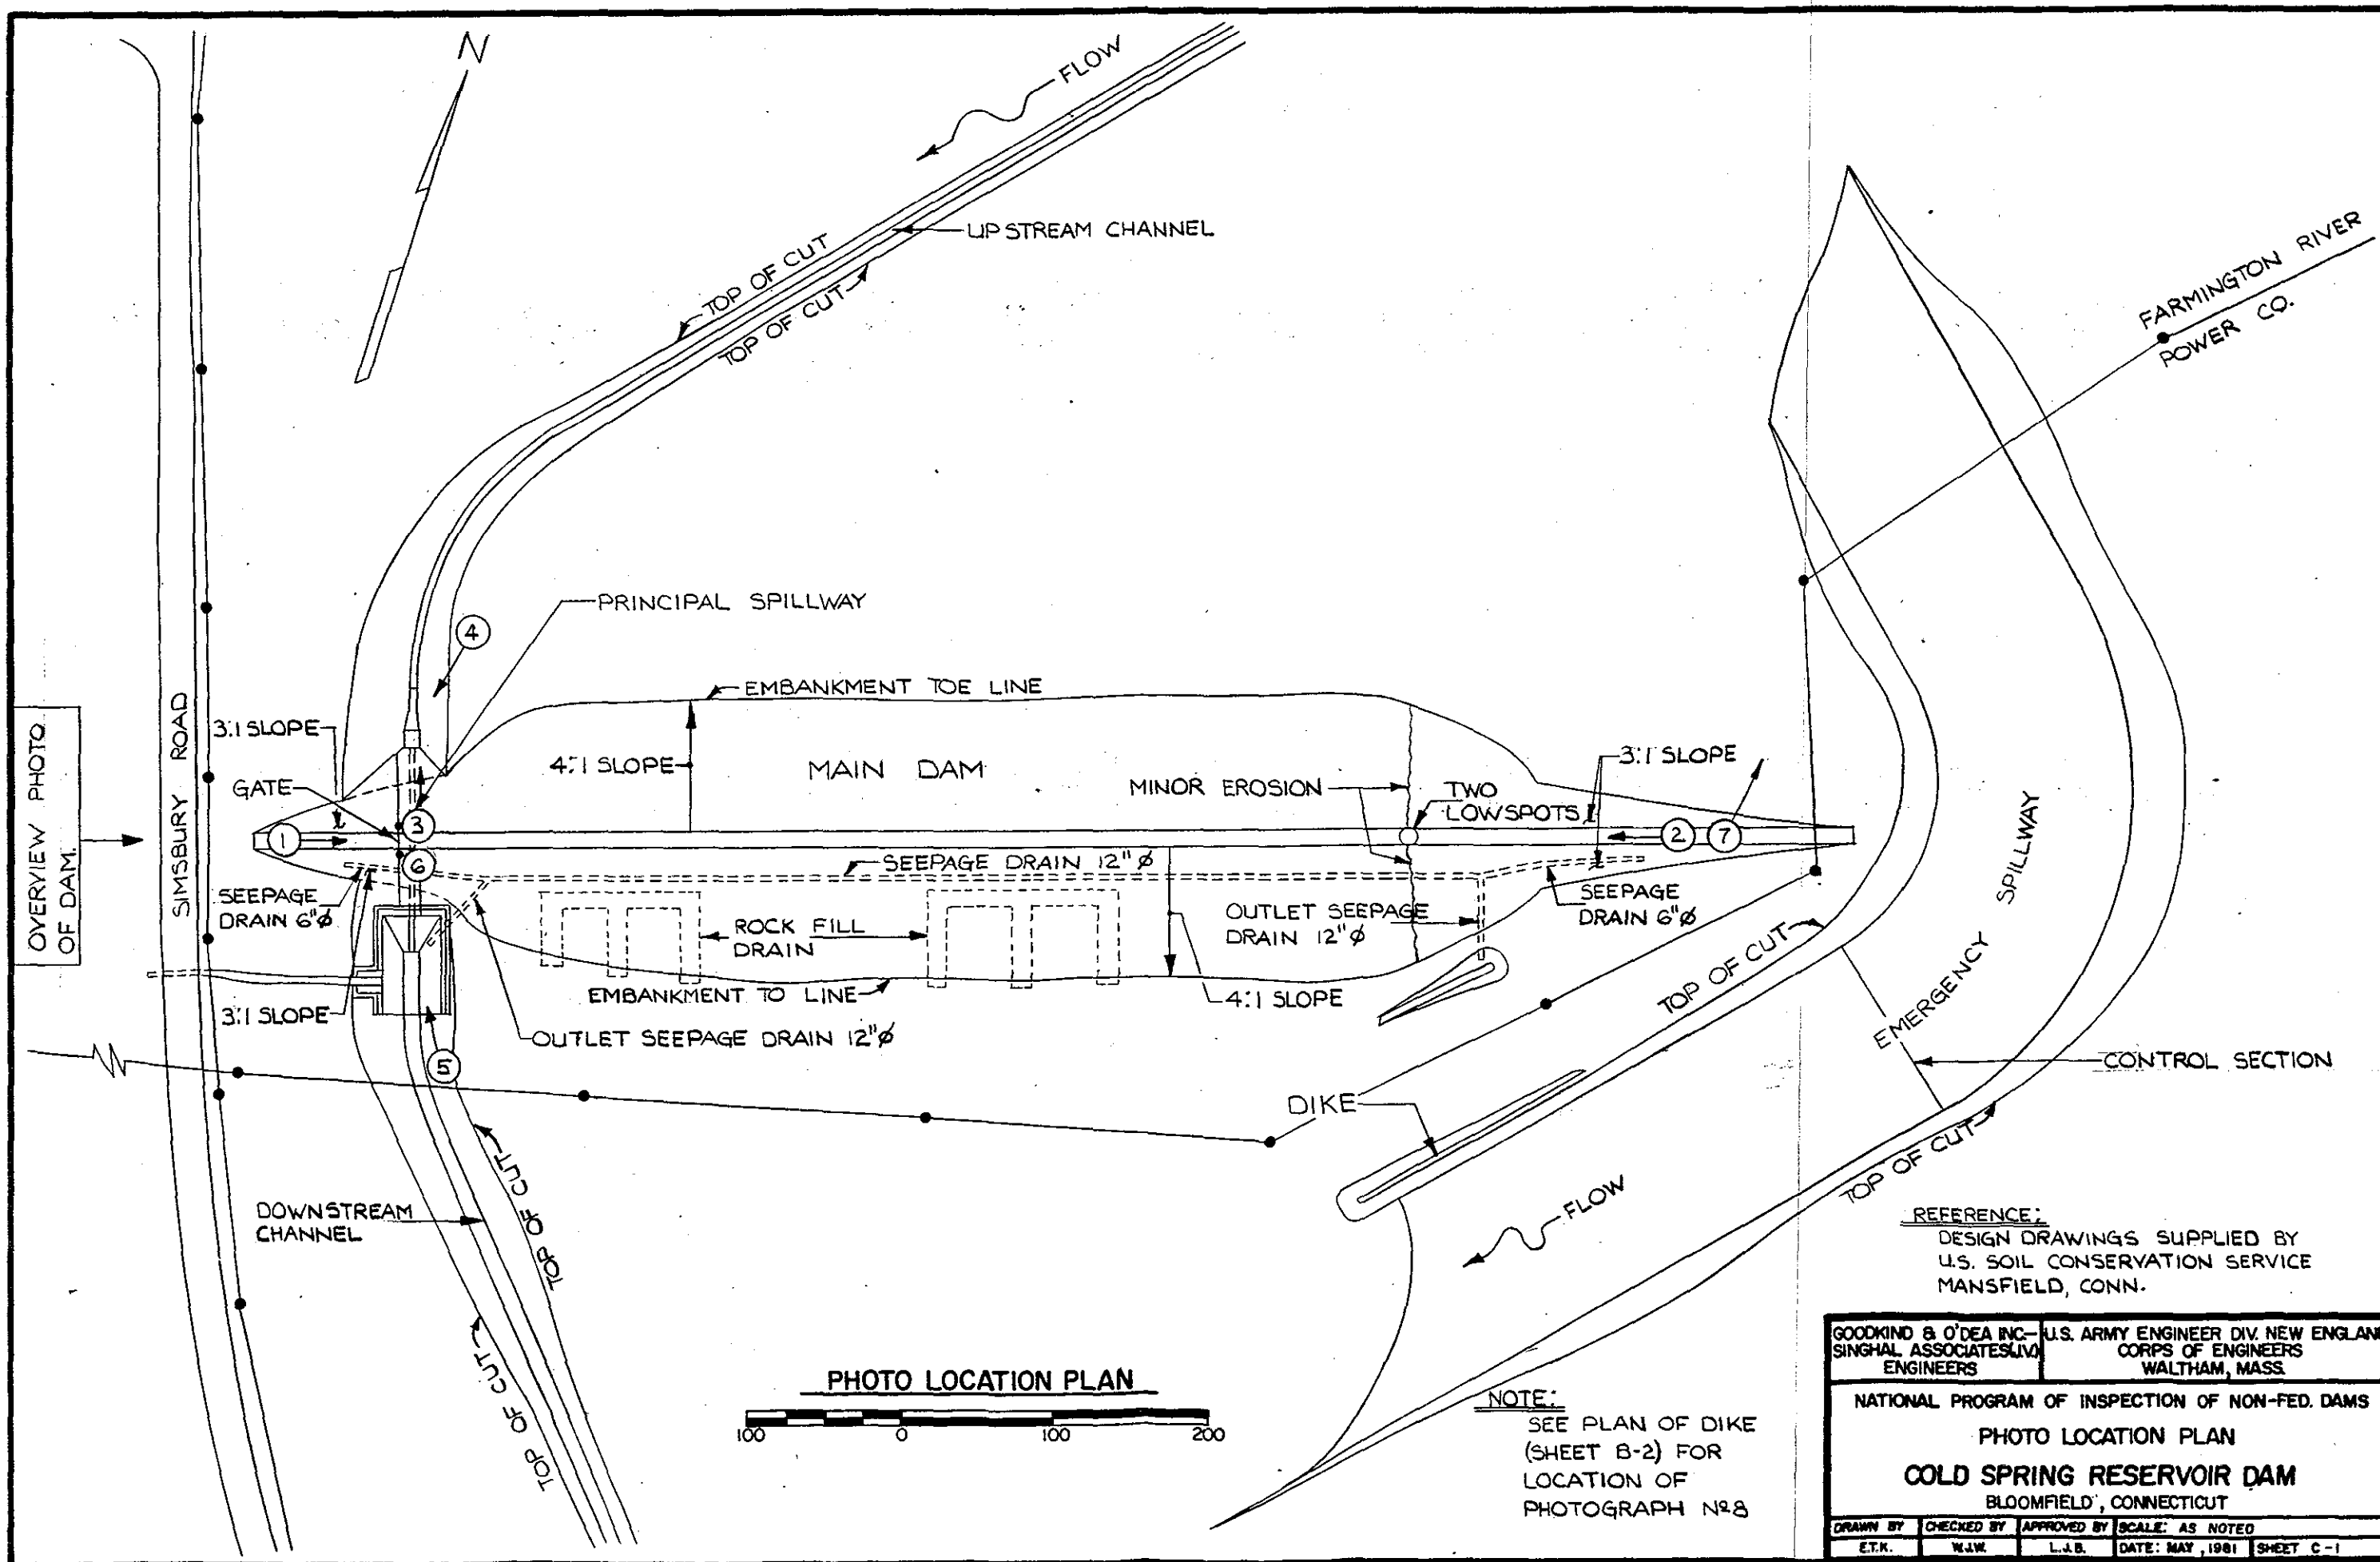
The dam is a grass covered, earthfill embankment with a gravel underdrain system on the downstream side. No sign of lateral movement or misalignment was observed as shown by Photos 1 and 2. Two low spots, each approximately 5 ft. by 8 ft. and 6" deep, were noted and are indicated on the general dam plan in Appendix B. Minor erosion down the embankment slopes was associated with these low spots, which is also shown on the general dam plan. The dam embankment was covered by a well developed growth of grass with minor vehicular rutting along the crest.

PHOTO 1 - View looking east along  
top of dam embankment.
